# Manhole Inspection Summary

Manhole # S43I\_\_034MH

Insp Date: **4/29/08 1:05 PM**

**Location** Address: **1724 bank st**

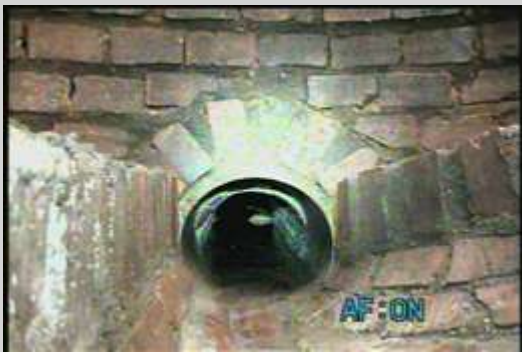
12 O'Clock Outflow

8 in. Circular Gravity Sewer  
Pipe Out @ 12 O'Clock

Invert Depth: **8.66** (ft.) Flow Characteristics: **Fast**

Deposits: ☒ None ☐ Mud ☐ Sludge ☐ **Debris** ☐ Grease

Infiltration: **None** Pipe Seal Cond: **Unknown**

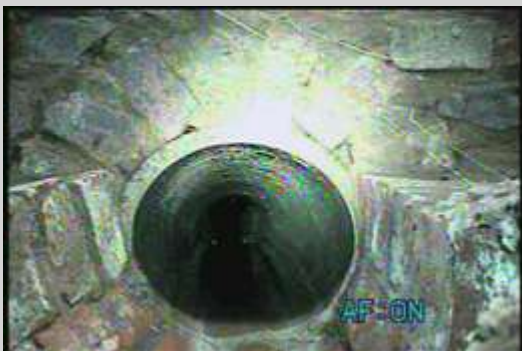
3 O'Clock Inflow

8 in. Circular Gravity Sewer  
Pipe In @ 3 O'Clock

Infiltration: **None** Pipe Seal Cond: **Unknown**
